Site No. 8

SAKONNET POINT

Little Compton
State Route 77 (Sakonnet Point Road)

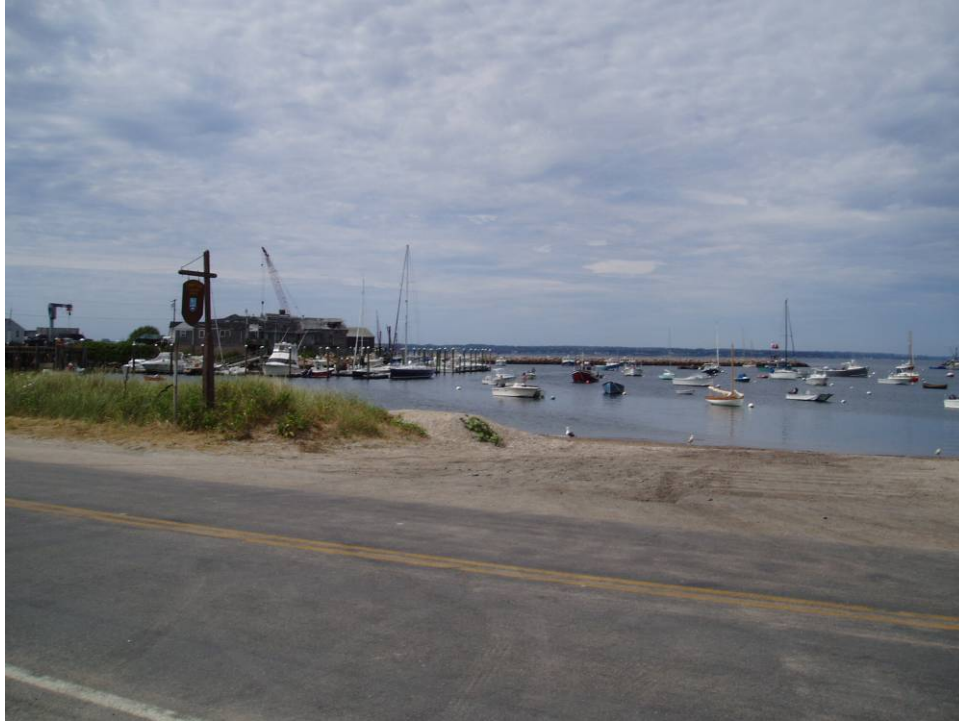
Photo 1. RIDEM-managed boat launch at Sakonnet Harbor. A small boat-trailer-only parking lot is located directly across the street.

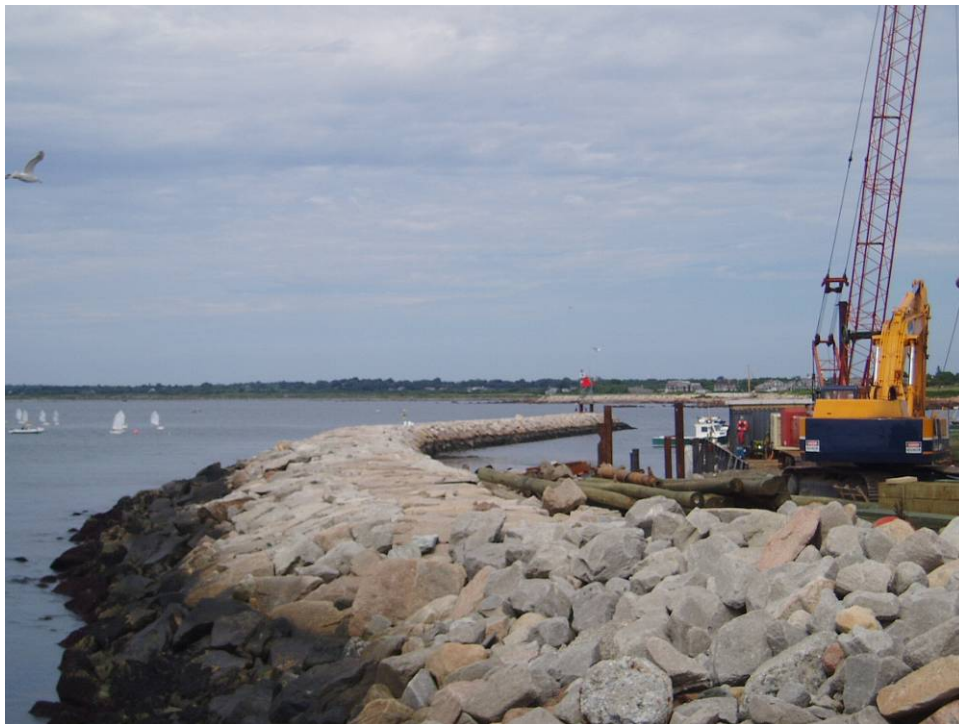
Photo 2. Looking northeast from start of breakwater / end of Bluff Head Avenue. Both recreational sailing (left) and marine construction (foreground right) are visible.

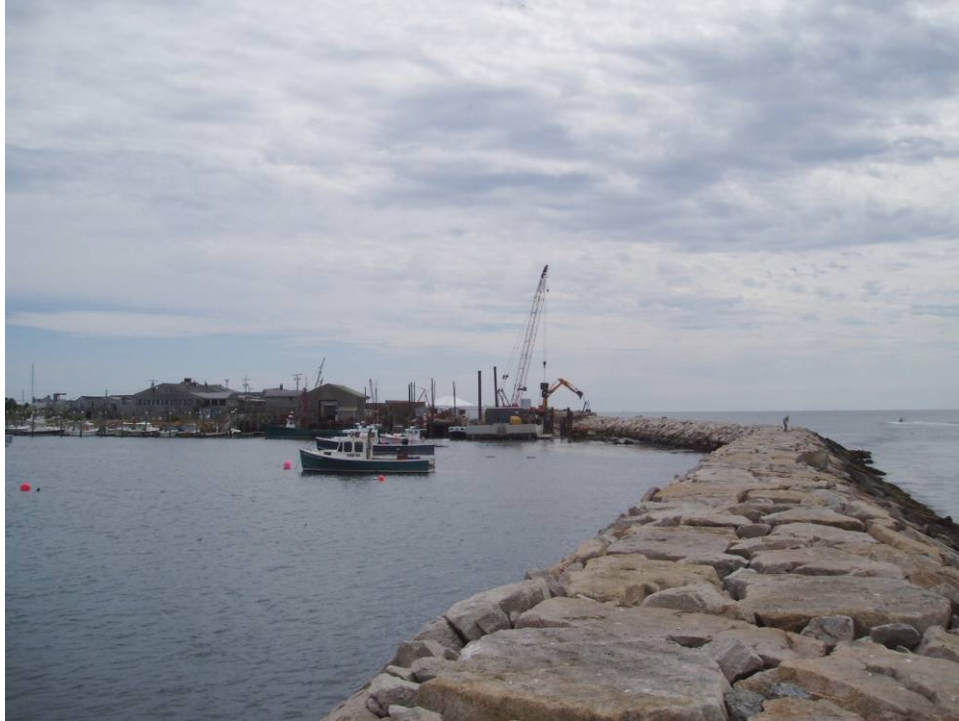
Photo 3. Looking back (southwest) along breakwater. Marina facilities are currently undergoing reconstruction.

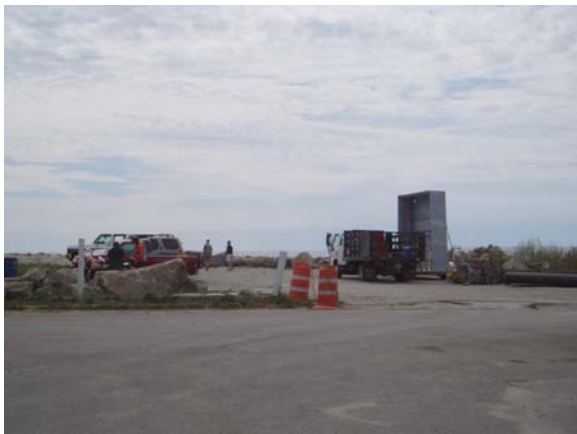
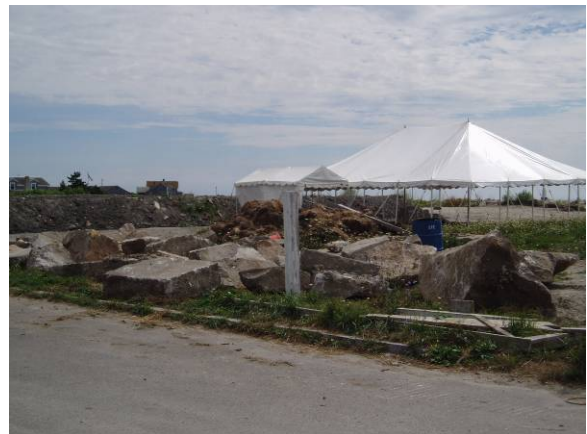
Public parking at the site is most readily offered by a small paved parking area on a generally unimproved parcel near the head of the breakwater (see Photo 4A). While research indicates that this parcel is privately owned, it was observed to be used for public parking and currently offers space for approximately 15 vehicles. Immediately south of this parking area, portions of the lot are used as stockpiling areas for the ongoing construction work (Photo 4B). Parking is also possible in certain poorly-defined locations elsewhere along harbor roads, however several lots are posted for private use only. The lot at the RIDEM boat ramp is designated for use only by vehicles with boat trailers.

Photos 4A and 4B. Lot along westerly shoreline near breakwater, currently used for public parking (4A) and material stockpiling (4B)

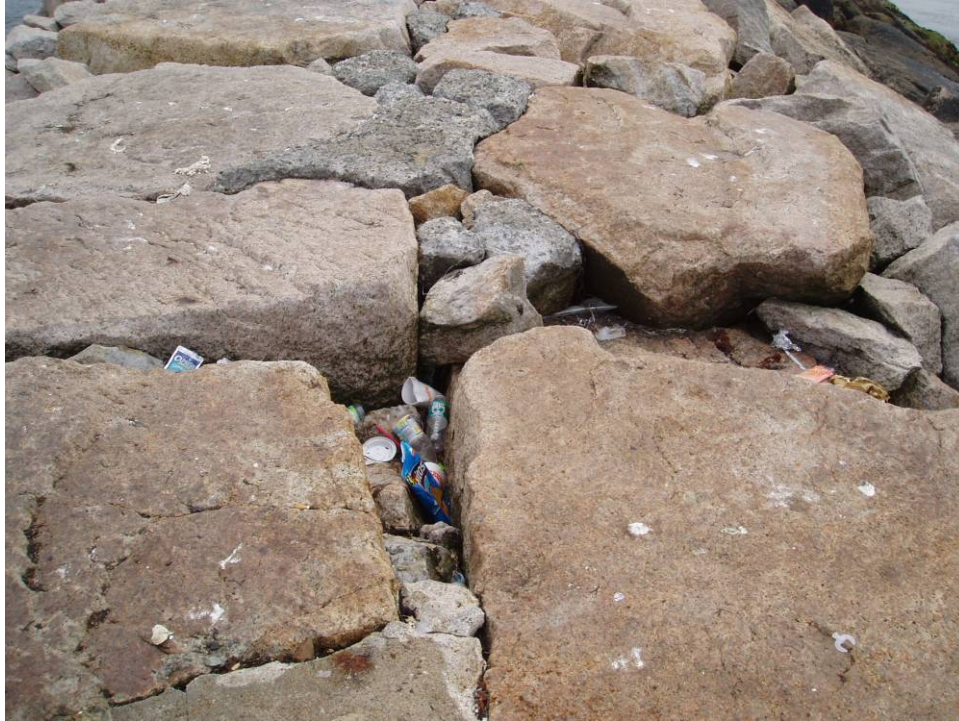
At over 700 feet in length, the existing stone breakwater currently offers ample frontage to quality recreational fishing along its ocean side. The major limitation inherent in this structure is lack of equitable access, as there are no viable fishing spots at the site for persons with disabilities, and the breakwater may be difficult to access by children and elderly persons due to the irregular footing along the rocks (particularly at the head of the breakwater ,see Photo 2). The ongoing marine construction immediately inside the breakwater (Photos 2, 3) currently requires users of the breakwater to walk along a longer stretch of uneven stone rip rap to bypass this work. With the exception of a single portable toilet (most likely serving the ongoing construction) and a trash receptacle, the site offers virtually no public use amenities. The breakwater itself also does not appear to be maintained, as it is characterized by a high amount of litter between the rocks along its length (Photo 5).

Photo 5. Typical litter condition along breakwater.

In the consideration of the elements to be developed as part of the Public Access Plan, certain low-priority minor improvements could potentially be implemented to enhance public use and enjoyment of the site, such as the provision of additional public parking (beyond the 6 spaces required) and public restrooms. The implementation of either would be contingent upon the availability of landside area in the vicinity of the breakwater, though most properties along Bluff Head Avenue are privately owned (including the parcel currently used for public parking). As previously noted, the aesthetic quality of the breakwater is currently marred by a high amount of litter along its length. It may be worthwhile to consider maintaining this structure through an adopt-a-spot program, possibly by a recreational fishing organization or other local interest.

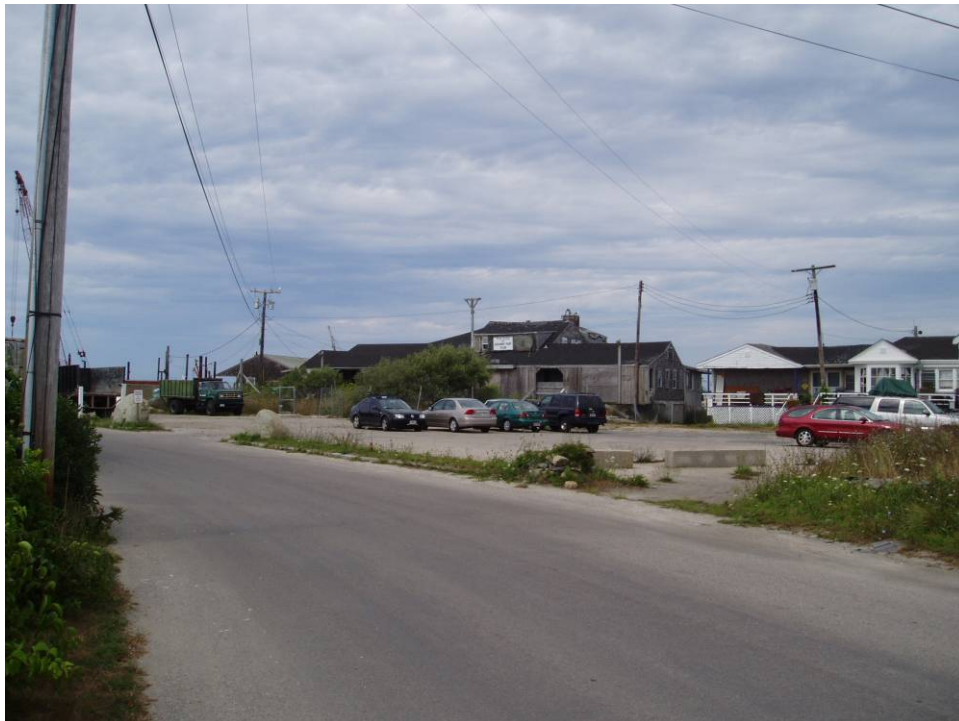
Of relevance to future public accessibility of the site is the proposed development of the Sakonnet Point Club, a private recreation facility to be constructed along the harbor on the easterly Bluff Head Avenue (see Photo 6). As part of the CRMC Assent Application for this project, the applicant is required to develop a Public Access Plan for the site in accordance with Section 335 of the *Coastal Resources Management Program*. Site-specific required elements of this plan include (a) maintaining public access to the existing Army Corps breakwater and (b) providing a minimum of 6 dedicated parking spaces for public use.

Photo 6. Marina facilities along Bluff Head Avenue. Parking in the foreground lot is posted for marina use only; the future site of the Sakonnet Point Club is in the background.

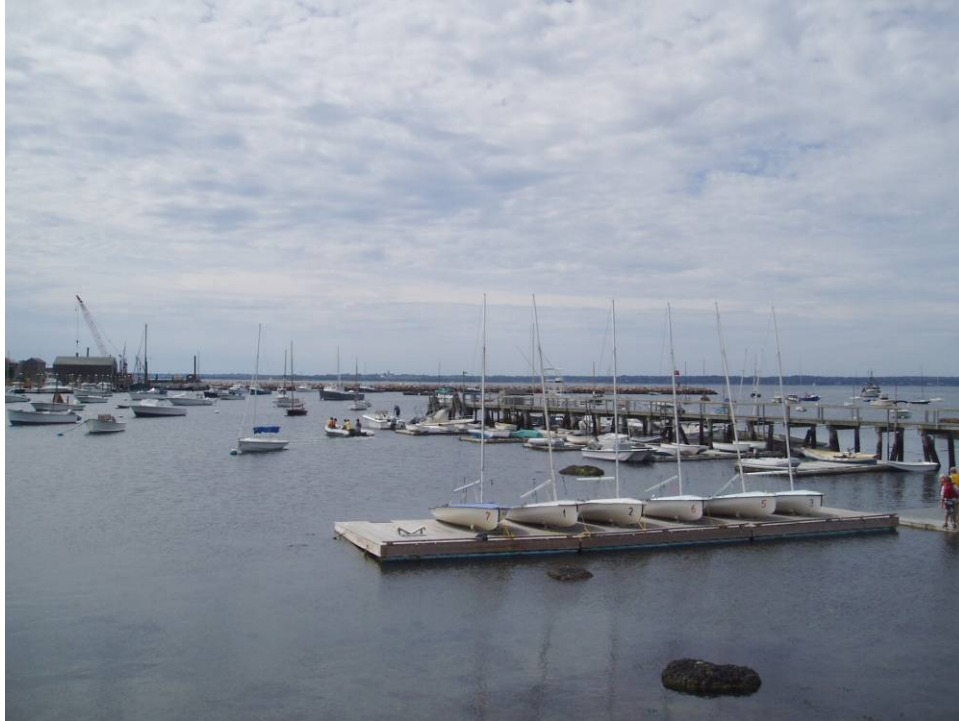
Photo 7. Sakonnet Harbor looking northwest. The dock and floats in the foreground are used by the Sakonnet Yacht Club.

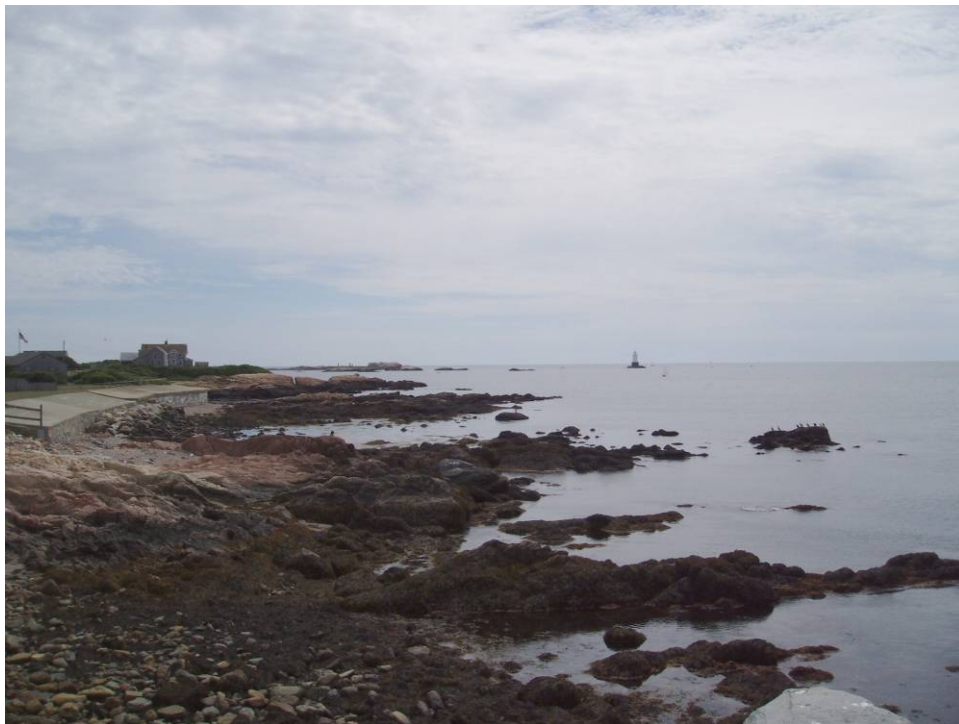
Photo 8. Westerly shoreline of Sakonnet Point looking south. The rocky shoreline limits the potential for structural development along this coast.
